# Uniform Mitigation Verification Inspection Form

**Subject: Uniform Mitigation Verification Inspection Form  
Rothmoor Estates Condominium  
Building 1  
101-105 Mindy Drive  
Largo, Florida**

Prescott Engineering, LLC (PE) was requested to provide complete a wind mitigation report for the above listed report. The inspection was completed on May 21, 2019. Below is photographic documentation for the Uniform Mitigation Verification Inspection Form.

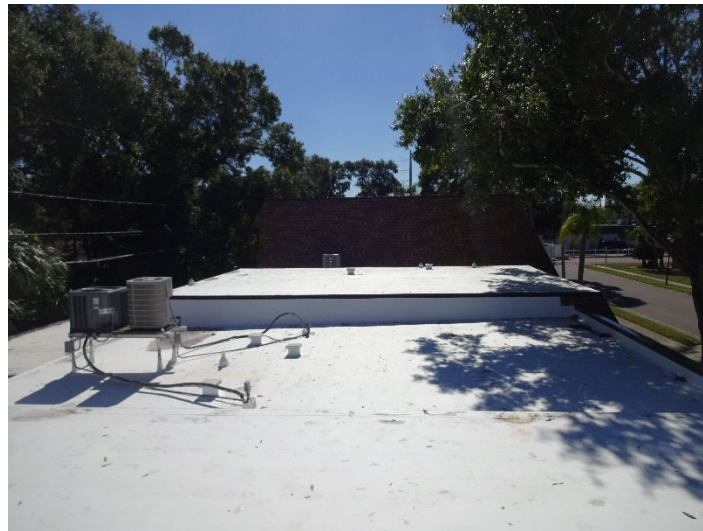
**Figure 1 – Roof Layout**

- ☐ A. Hip Roof      Hip roof with no other roof shapes greater than 10% of the total roof system perimeter.  
Total length of non-hip features: \_\_\_\_\_ feet; Total roof system perimeter: \_\_\_\_\_ feet
- ☐ B. Flat Roof      Roof on a building with 5 or more units where at least 90% of the main roof area has a roof slope of less than 2:12. Roof area with slope less than 2:12 \_\_\_\_\_ sq ft; Total roof area \_\_\_\_\_ sq ft
- ☒ C. Other Roof      Any roof that does not qualify as either (A) or (B) above. 7,300 sq ft flat; 4,100 mansard

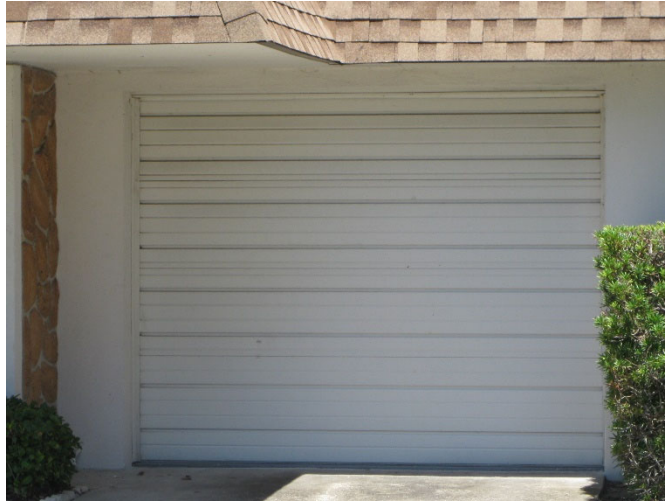
**Figure 2 – Typical Garage Door**

| Opening Protection Level Chart<br>Place an "X" in each row to identify all forms of protection in use for each opening type. Check only one answer below (A thru X), based on the weakest form of protection (lowest row) for any of the Glazed openings and indicate the weakest form of protection (lowest row) for Non-Glazed openings. | | Glazed Openings | | | | Non-Glazed Openings | |
|---|---|---|---|---|---|---|---|
| X | No Windborne Debris Protection | X | X | | | X | X |

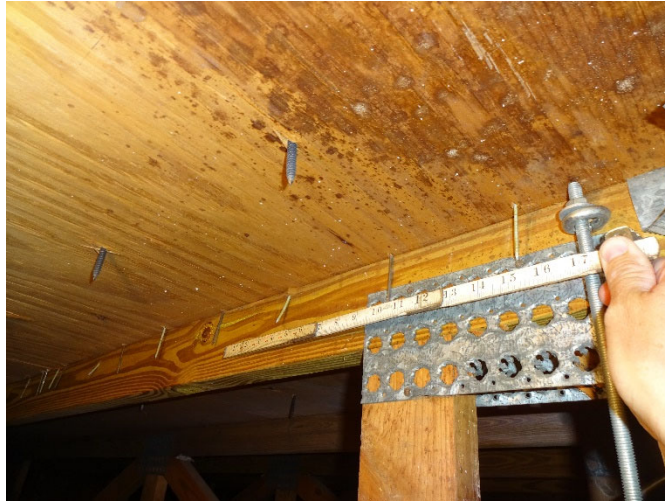
**Figure 5 – Deck to Truss Attachment**

- ☒ C. Plywood/OSB roof sheathing with a minimum thickness of 7/16" inch attached to the roof truss/rafter (spaced a maximum of 24" inches o.c.) by 8d common nails spaced a maximum of 6" inches in the field. -OR- Dimensional lumber/Tongue & Groove decking with a minimum of 2 nails per board (or 1 nail per board if each board is equal to or less than 6 inches in width). -OR- Any system of screws, nails, adhesives, other deck fastening system or truss/rafter spacing that is shown to have an equivalent

or greater resistance than 8d common nails spaced a maximum of 6 inches in the field or has a mean uplift resistance of at least 182 psf.
