# Uniform Mitigation Verification Inspection Form

| Address: 1001-1007 Cara Drive | | Home Phone: |

**Subject: Uniform Mitigation Verification Inspection Form  
Rothmoor Estates Condominium  
Building  
1001-1007 Cara Drive  
Largo, Florida**

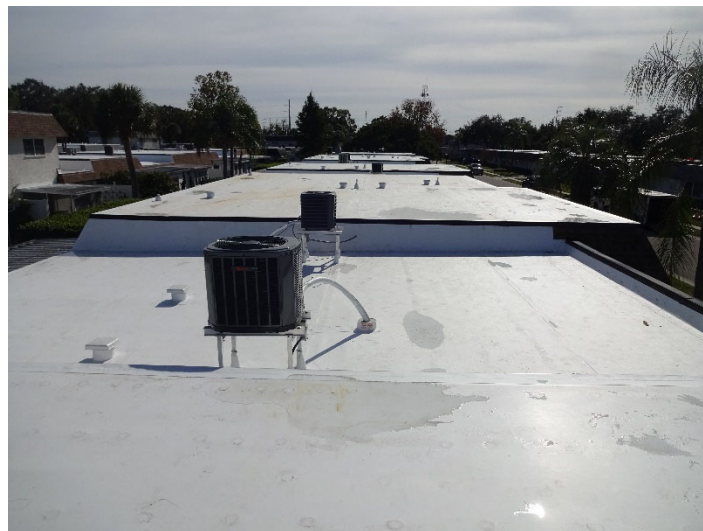
**Figure 1 – Roof Layout**

- ☐ A. Hip Roof      Hip roof with no other roof shapes greater than 10% of the total roof system perimeter.  
Total length of non-hip features: \_\_\_\_\_ feet; Total roof system perimeter: \_\_\_\_\_ feet
- ☐ B. Flat Roof      Roof on a building with 5 or more units where at least 90% of the main roof area has a roof slope of less than 2:12. Roof area with slope less than 2:12 \_\_\_\_\_ sq ft; Total roof area \_\_\_\_\_ sq ft
- ☒ C. Other Roof      Any roof that does not qualify as either (A) or (B) above. 9,400 sq ft flat; 3,300 sq ft mansard

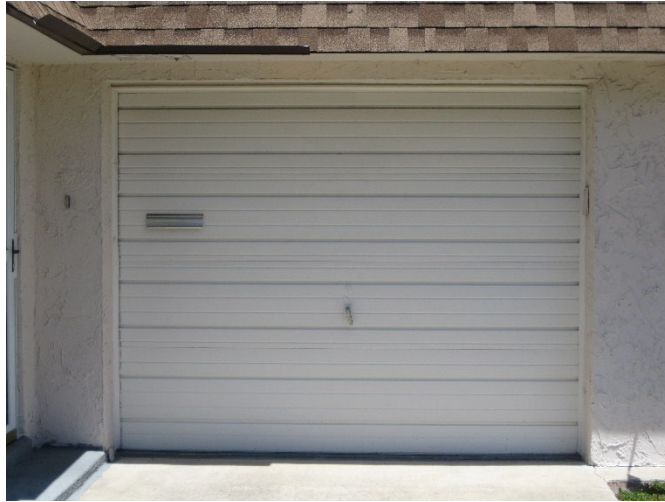
**Figure 2 – Typical Garage Door**

| Opening Protection Level Chart<br>Place an "X" in each row to identify all forms of protection in use for each opening type. Check only one answer below (A thru X), based on the weakest form of protection (lowest row) for any of the Glazed openings and indicate the weakest form of protection (lowest row) for Non-Glazed openings. | | Glazed Openings | | | | Non-Glazed Openings | |
|---|---|---|---|---|---|---|---|
| X | No Windborne Debris Protection | X | X | | | X | X |

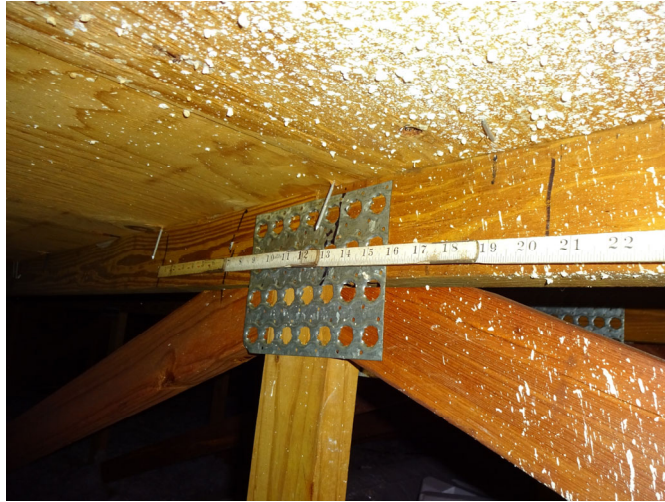
**Figure 5 – Deck to Truss Attachment**

- ☒ C. Plywood/OSB roof sheathing with a minimum thickness of 7/16" inch attached to the roof truss/rafter (spaced a maximum of 24" inches o.c.) by 8d common nails spaced a maximum of 6" inches in the field. -OR- Dimensional lumber/Tongue & Groove decking with a minimum of 2 nails per board (or 1 nail per board if each board is equal to or less than 6 inches in width). -OR- Any system of screws, nails, adhesives, other deck fastening system or truss/rafter spacing that is shown to have an equivalent
