# Uniform Mitigation Verification Inspection Form

| Address: 1101-1104 Cara Drive | | Home Phone: |

**Subject: Uniform Mitigation Verification Inspection Form  
Rothmoor Estates Condominium  
Building 11  
1101-1104 Cara Drive  
Largo, Florida**

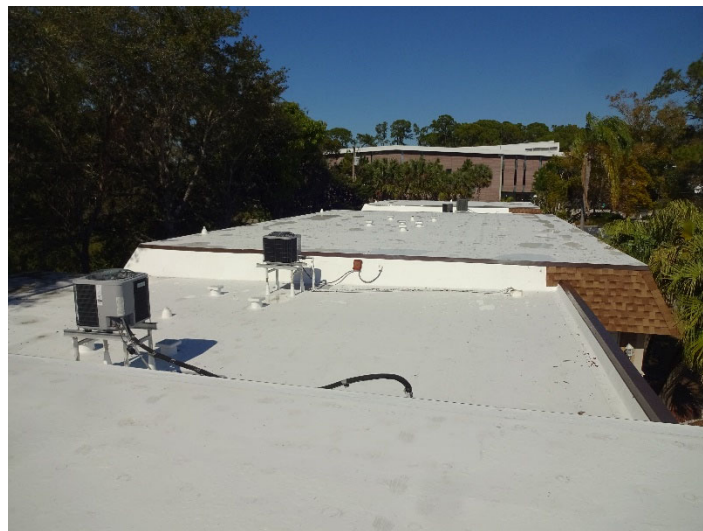
- ☐ A. Hip Roof      Hip roof with no other roof shapes greater than 10% of the total roof system perimeter.  
Total length of non-hip features: \_\_\_\_\_ feet; Total roof system perimeter: \_\_\_\_\_ feet
- ☐ B. Flat Roof      Roof on a building with 5 or more units where at least 90% of the main roof area has a roof slope of less than 2:12. Roof area with slope less than 2:12 \_\_\_\_\_ sq ft; Total roof area \_\_\_\_\_ sq ft
- ☒ C. Other Roof      Any roof that does not qualify as either (A) or (B) above. 6,400 sq ft flat; 6,000 sq ft mansard

**Figure 1 – Roof Layout**

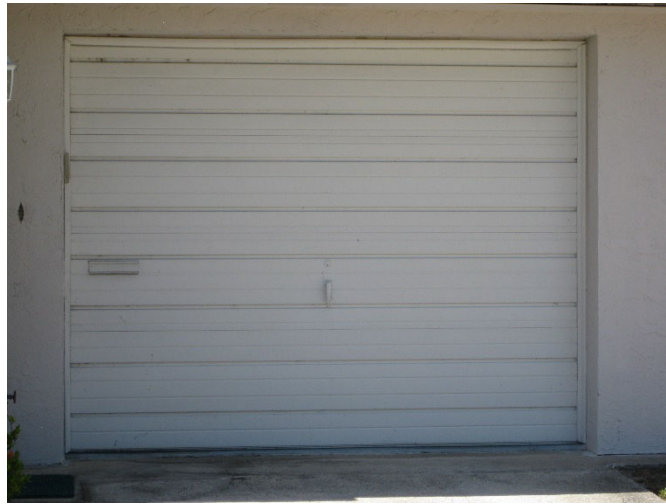
| Opening Protection Level Chart<br>Place an "X" in each row to identify all forms of protection in use for each opening type. Check only one answer below (A thru X), based on the weakest form of protection (lowest row) for any of the Glazed openings and indicate the weakest form of protection (lowest row) for Non-Glazed openings. | | Glazed Openings | | | | Non-Glazed Openings | |
|---|---|---|---|---|---|---|---|
| X | No Windborne Debris Protection | X | X | | | X | X |

**Figure 2 – Typical Garage Door**

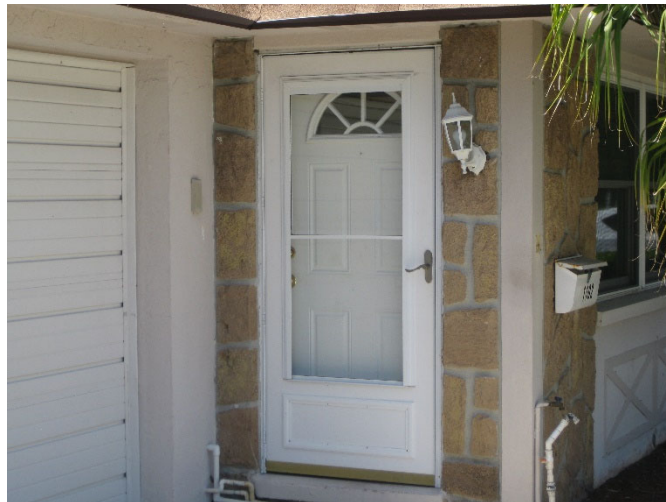
**Figure 3 – Typical Front Door**

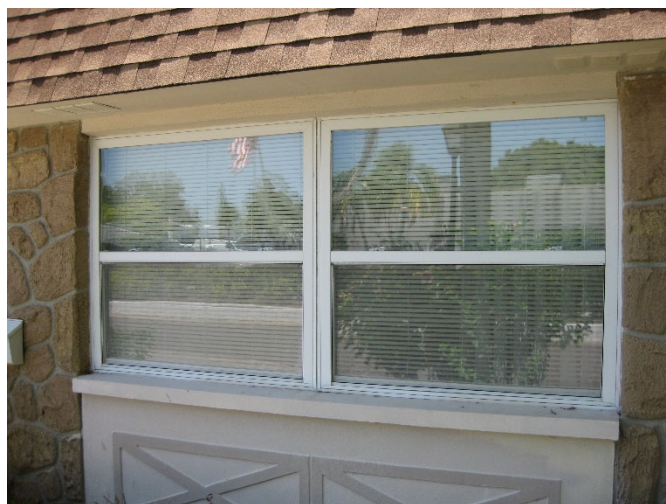
**Figure 4 – Typical Window**

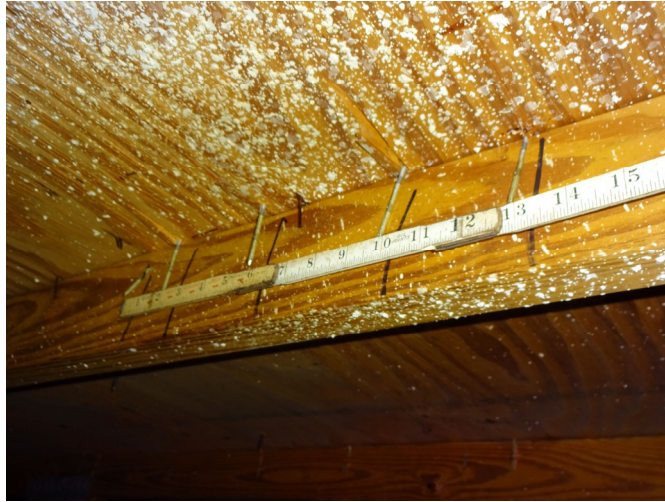
- ☒ C. Plywood/OSB roof sheathing with a minimum thickness of 7/16" inch attached to the roof truss/rafter (spaced a maximum of 24" inches o.c.) by 8d common nails spaced a maximum of 6" inches in the field. -OR- Dimensional lumber/Tongue & Groove decking with a minimum of 2 nails per board (or 1 nail per board if each board is equal to or less than 6 inches in width). -OR- Any system of screws, nails, adhesives, other deck fastening system or truss/rafter spacing that is shown to have an equivalent

**Figure 5 – Deck to Truss Attachment**
