# Uniform Mitigation Verification Inspection Form

**Subject: Uniform Mitigation Verification Inspection Form  
Rothmoor Estates Condominium  
Building 14  
1401-1407 Cara Drive  
Largo, Florida**

***Uniform Mitigation Verification Inspection Form***  
***Rothmoor Estate Condominiums***  
***1401-1407 Cara Drive***  
***Largo, Florida***

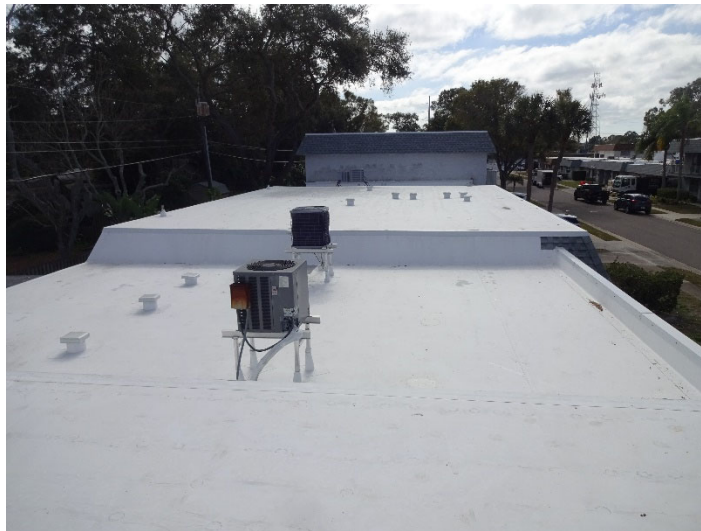
**Figure 1 – Roof Layout**

- ☐ A. Hip Roof      Hip roof with no other roof shapes greater than 10% of the total roof system perimeter.  
Total length of non-hip features: \_\_\_\_\_ feet; Total roof system perimeter: \_\_\_\_\_ feet
- ☐ B. Flat Roof      Roof on a building with 5 or more units where at least 90% of the main roof area has a roof slope of less than 2:12. Roof area with slope less than 2:12 \_\_\_\_\_ sq ft; Total roof area \_\_\_\_\_ sq ft
- ☒ C. Other Roof      Any roof that does not qualify as either (A) or (B) above.      10,500 sq ft flat; 4,100 mansard

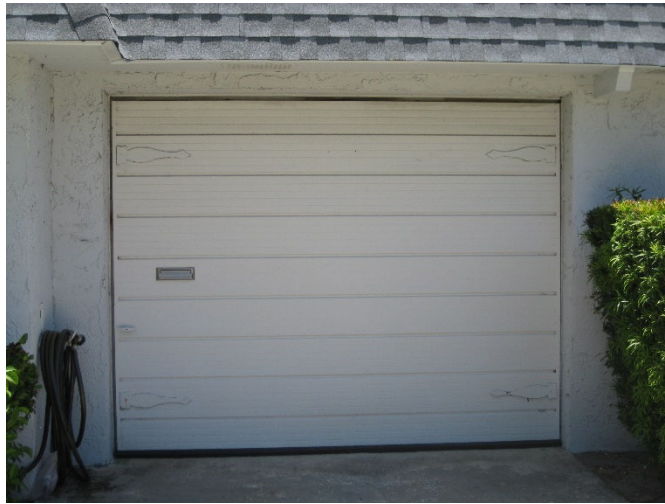
**Figure 2 – Typical Garage Door**

| Opening Protection Level Chart<br>Place an "X" in each row to identify all forms of protection in use for each opening type. Check only one answer below (A thru X), based on the weakest form of protection (lowest row) for any of the Glazed openings and indicate the weakest form of protection (lowest row) for Non-Glazed openings. | | Glazed Openings | | | | Non-Glazed Openings | |
|---|---|---|---|---|---|---|---|
| X | No Windborne Debris Protection | X | X | | | X | X |

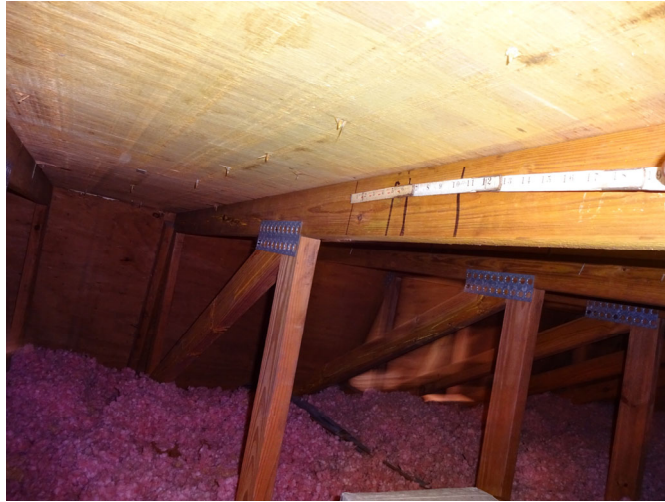
**Figure 5 – Deck to Truss Attachment**

- ☒ C. Plywood/OSB roof sheathing with a minimum thickness of 7/16" inch attached to the roof truss/rafter (spaced a maximum of 24" inches o.c.) by 8d common nails spaced a maximum of 6" inches in the field. -OR- Dimensional lumber/Tongue & Groove decking with a minimum of 2 nails per board (or 1 nail per board if each board is equal to or less than 6 inches in width). -OR- Any system of screws, nails, adhesives, other deck fastening system or truss/rafter spacing that is shown to have an equivalent

or greater resistance than 8d common nails spaced a maximum of 6 inches in the field or has a mean uplift resistance of at least 182 psf.
