# Uniform Mitigation Verification Inspection Form

| Address: <b>401-404 Mindy Drive</b> | | Home Phone: |

**Subject: Uniform Mitigation Verification Inspection Form  
Rothmoor Estates Condominium  
Building 4  
401-404 Mindy Drive  
Largo, Florida**

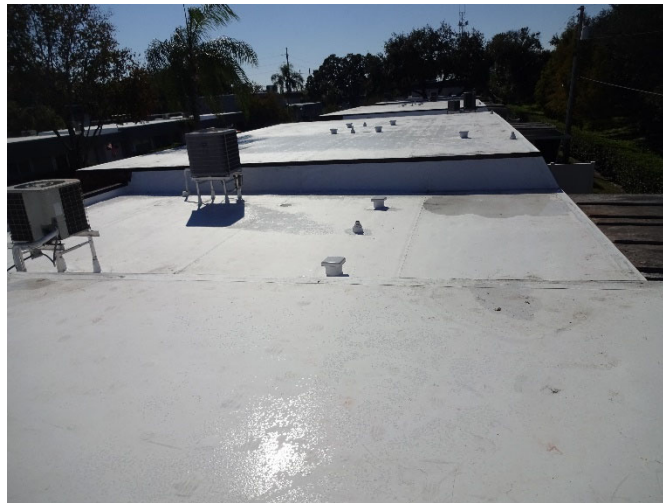
**Figure 1 – Roof Layout**

- ☐ A. Hip Roof      Hip roof with no other roof shapes greater than 10% of the total roof system perimeter.  
Total length of non-hip features: \_\_\_\_\_ feet; Total roof system perimeter: \_\_\_\_\_ feet
- ☐ B. Flat Roof      Roof on a building with 5 or more units where at least 90% of the main roof area has a roof slope of less than 2:12. Roof area with slope less than 2:12 \_\_\_\_\_ sq ft; Total roof area \_\_\_\_\_ sq ft
- ☒ C. Other Roof      Any roof that does not qualify as either (A) or (B) above.      6,400 sq ft flat; 6,000 sq ft mansard

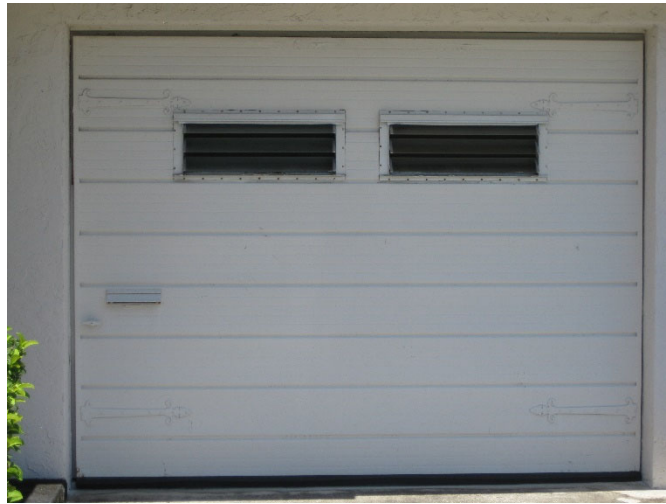
**Figure 2 – Typical Garage Door**

| Opening Protection Level Chart<br>Place an "X" in each row to identify all forms of protection in use for each opening type. Check only one answer below (A thru X), based on the weakest form of protection (lowest row) for any of the Glazed openings and indicate the weakest form of protection (lowest row) for Non-Glazed openings. | | Glazed Openings | | | | Non-Glazed Openings | |
|---|---|---|---|---|---|---|---|
| X | No Windborne Debris Protection | X | X | | | X | X |

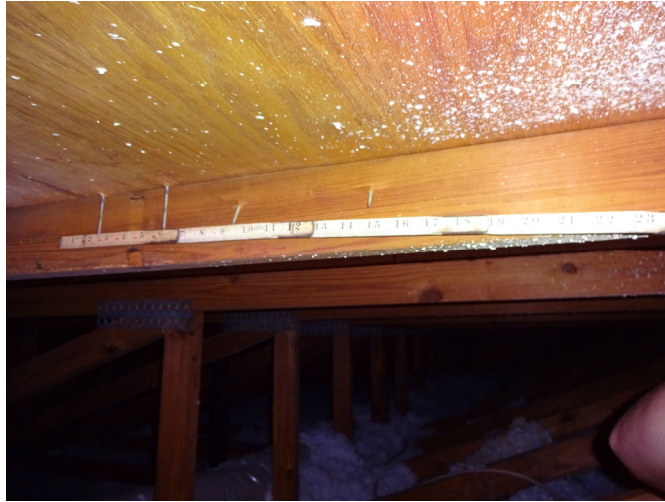
**Figure 5 – Deck to Truss Attachment**

- ☒ C. Plywood/OSB roof sheathing with a minimum thickness of 7/16" inch attached to the roof truss/rafter (spaced a maximum of 24" inches o.c.) by 8d common nails spaced a maximum of 6" inches in the field. -OR- Dimensional lumber/Tongue & Groove decking with a minimum of 2 nails per board (or 1 nail per board if each board is equal to or less than 6 inches in width). -OR- Any system of screws, nails, adhesives, other deck fastening system or truss/rafter spacing that is shown to have an equivalent

or greater resistance than 8d common nails spaced a maximum of 6 inches in the field or has a mean uplift resistance of at least 182 psf.
