# Uniform Mitigation Verification Inspection Form

| Address: 501-504 Cara Court | | Home Phone: |

**Subject: Uniform Mitigation Verification Inspection Form  
Rothmoor Estates Condominium  
Building 5  
501-504 Cara Court  
Largo, Florida**

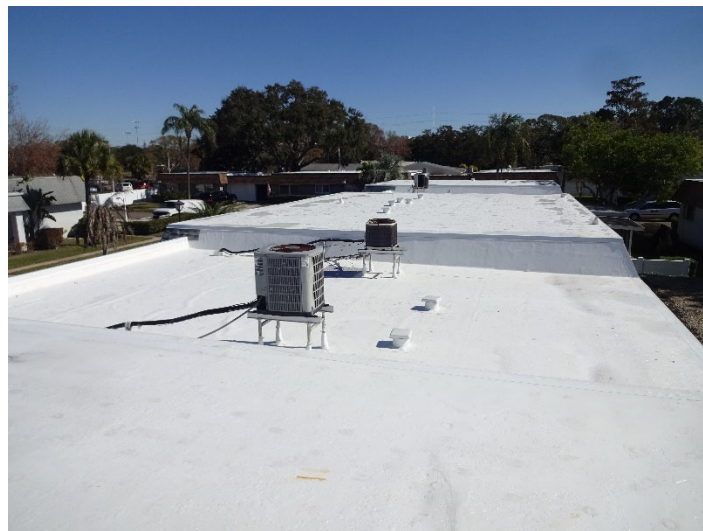
**Figure 1 – Roof Layout**

- ☐ A. Hip Roof      Hip roof with no other roof shapes greater than 10% of the total roof system perimeter.  
Total length of non-hip features: \_\_\_\_\_ feet; Total roof system perimeter: \_\_\_\_\_ feet
- ☐ B. Flat Roof      Roof on a building with 5 or more units where at least 90% of the main roof area has a roof slope of less than 2:12. Roof area with slope less than 2:12 \_\_\_\_\_ sq ft; Total roof area \_\_\_\_\_ sq ft
- ☒ C. Other Roof      Any roof that does not qualify as either (A) or (B) above.    6,300 sq ft flat; 2,000 sq ft mansard

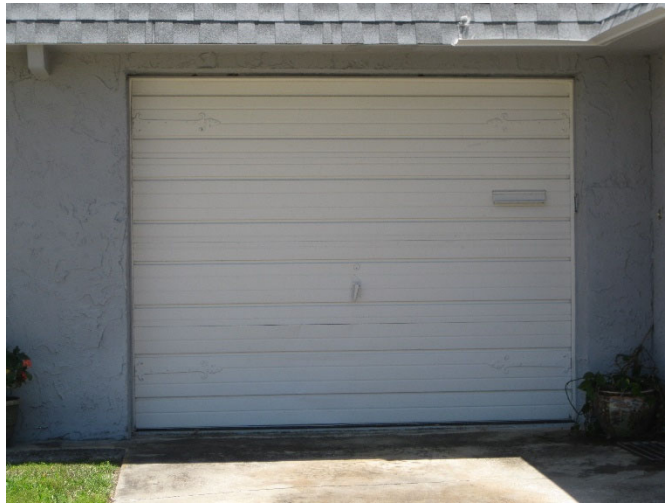
**Figure 2 – Typical Garage Door**

| Opening Protection Level Chart<br>Place an "X" in each row to identify all forms of protection in use for each opening type. Check only one answer below (A thru X), based on the weakest form of protection (lowest row) for any of the Glazed openings and indicate the weakest form of protection (lowest row) for Non-Glazed openings. | | Glazed Openings | | | | Non-Glazed Openings | |
|---|---|---|---|---|---|---|---|
| X | No Windborne Debris Protection | X | X | | | X | X |

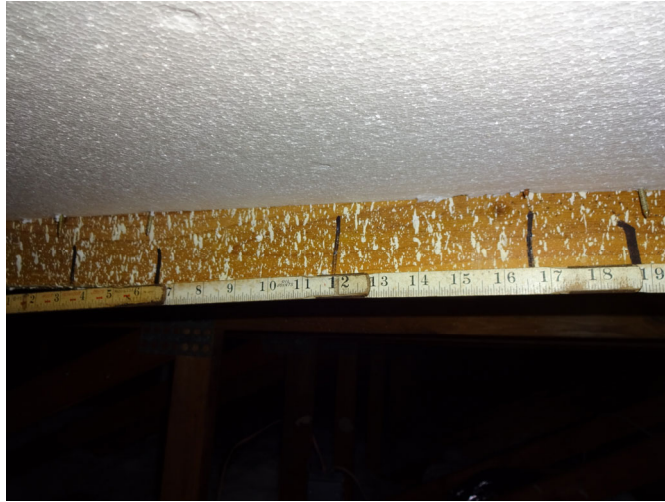
**Figure 5 – Deck to Truss Attachment**

- ☒ C. Plywood/OSB roof sheathing with a minimum thickness of 7/16" inch attached to the roof truss/rafter (spaced a maximum of 24" inches o.c.) by 8d common nails spaced a maximum of 6" inches in the field. -OR- Dimensional lumber/Tongue & Groove decking with a minimum of 2 nails per board (or 1 nail per board if each board is equal to or less than 6 inches in width). -OR- Any system of screws, nails, adhesives, other deck fastening system or truss/rafter spacing that is shown to have an equivalent
