# Uniform Mitigation Verification Inspection Form

**Subject: Uniform Mitigation Verification Inspection Form  
Rothmoor Estates Condominium  
Building 6  
601-608 Mindy Drive  
Largo, Florida**

***Uniform Mitigation Verification Inspection Form***  
***Rothmoor Estate Condominiums***  
***601-608 Mindy Drive***  
***Largo, Florida***

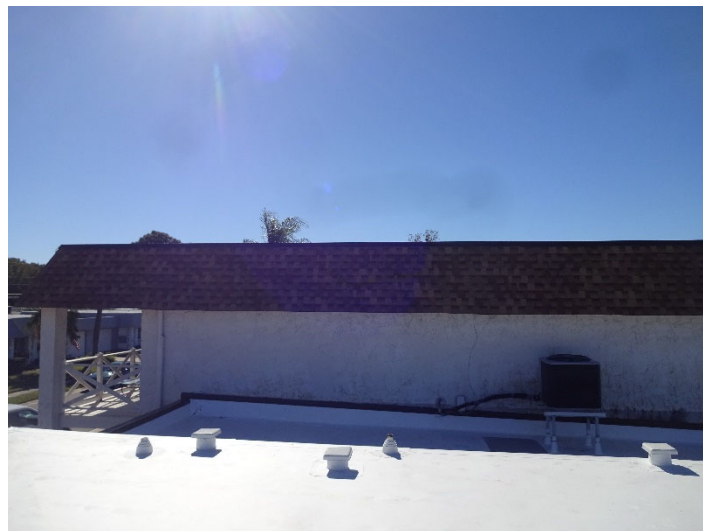
**Figure 1 – Roof Layout**

| 2.1 Roof Covering Type: | Permit Application Date | FBC or MDC Product Approval # | Year of Original Installation or Replacement | No Information Provided for Compliance |
|---|---|---|---|---|
| <input checked="" type="checkbox"/> 6. Other TPO | ____/____/____ | _____ | 2019 | <input type="checkbox"/> |

- ☐ A. Hip Roof      Hip roof with no other roof shapes greater than 10% of the total roof system perimeter.  
Total length of non-hip features: \_\_\_\_\_ feet; Total roof system perimeter: \_\_\_\_\_ feet
- ☐ B. Flat Roof      Roof on a building with 5 or more units where at least 90% of the main roof area has a roof slope of less than 2:12. Roof area with slope less than 2:12 \_\_\_\_\_ sq ft; Total roof area \_\_\_\_\_ sq ft
- ☒ C. Other Roof      Any roof that does not qualify as either (A) or (B) above.      12,000 sq ft flat; 4,200 mansard

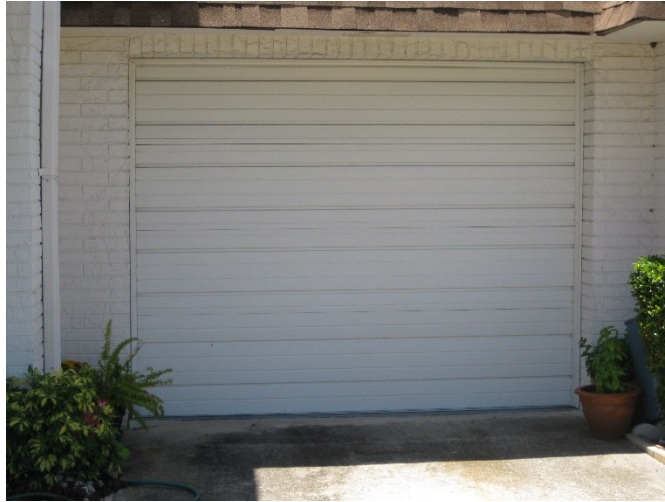
**Figure 2 – Typical Garage Door**

| Opening Protection Level Chart<br>Place an "X" in each row to identify all forms of protection in use for each opening type. Check only one answer below (A thru X), based on the weakest form of protection (lowest row) for any of the Glazed openings and indicate the weakest form of protection (lowest row) for Non-Glazed openings. | | Glazed Openings | | | | Non-Glazed Openings | |
|---|---|---|---|---|---|---|---|
| X | No Windborne Debris Protection | X | X | | | X | X |

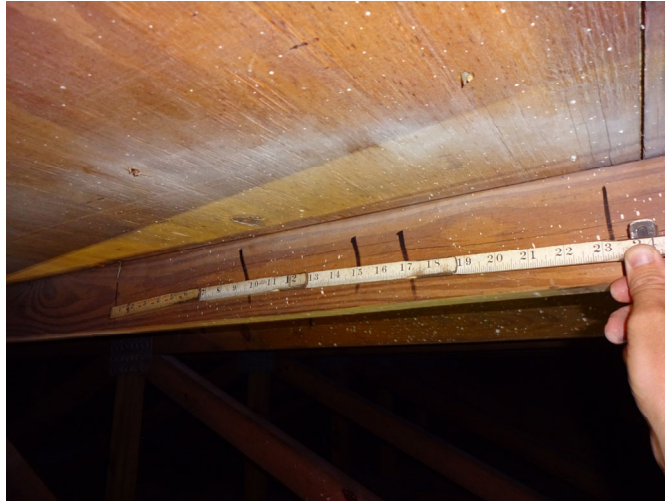
**Figure 5 – Deck to Truss Attachment**

- ☒ C. Plywood/OSB roof sheathing with a minimum thickness of 7/16" inch attached to the roof truss/rafter (spaced a maximum of 24" inches o.c.) by 8d common nails spaced a maximum of 6" inches in the field. -OR- Dimensional lumber/Tongue & Groove decking with a minimum of 2 nails per board (or 1 nail per board if each board is equal to or less than 6 inches in width). -OR- Any system of screws, nails, adhesives, other deck fastening system or truss/rafter spacing that is shown to have an equivalent

or greater resistance than 8d common nails spaced a maximum of 6 inches in the field or has a mean uplift resistance of at least 182 psf.
