# Uniform Mitigation Verification Inspection Form

**Subject: Uniform Mitigation Verification Inspection Form  
Rothmoor Estates Condominium  
Building 7  
701-708 Mindy Drive  
Largo, Florida**

***Uniform Mitigation Verification Inspection Form  
Rothmoor Estate Condominiums  
701-708 Mindy Drive  
Largo, Florida***

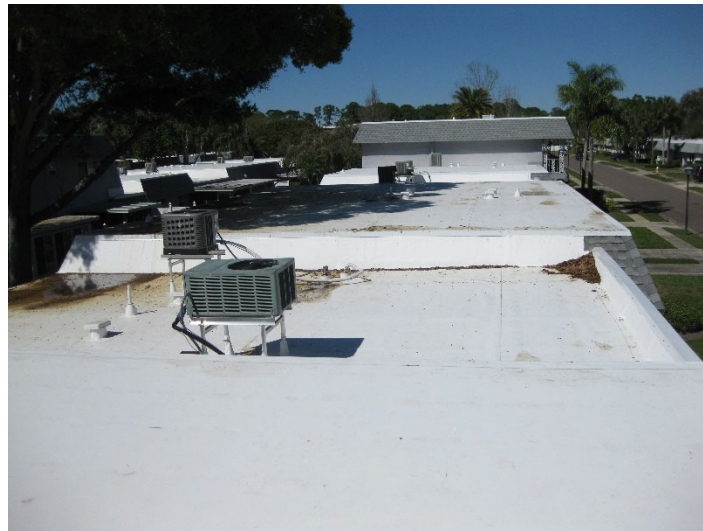
**Figure 1 – Roof Layout**

- ☐ A. Hip Roof      Hip roof with no other roof shapes greater than 10% of the total roof system perimeter.  
Total length of non-hip features: \_\_\_\_\_ feet; Total roof system perimeter: \_\_\_\_\_ feet
- ☐ B. Flat Roof      Roof on a building with 5 or more units where at least 90% of the main roof area has a roof slope of less than 2:12. Roof area with slope less than 2:12 \_\_\_\_\_ sq ft; Total roof area \_\_\_\_\_ sq ft
- ☒ C. Other Roof      Any roof that does not qualify as either (A) or (B) above.    12,000 sq ft flat; 4,200 mansard

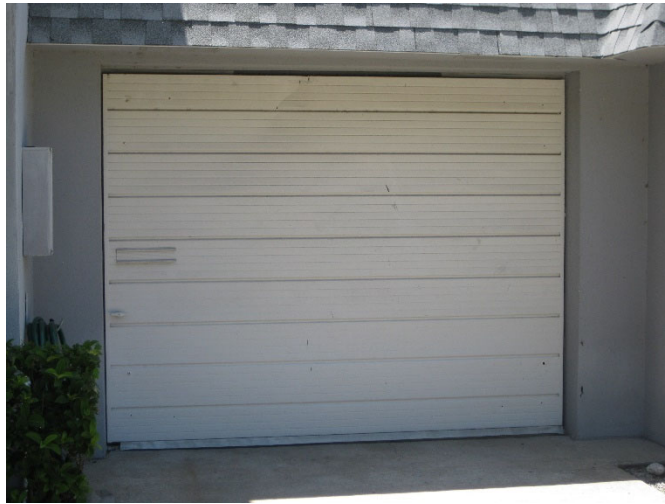
**Figure 2 – Typical Garage Door**

| Opening Protection Level Chart<br>Place an "X" in each row to identify all forms of protection in use for each opening type. Check only one answer below (A thru X), based on the weakest form of protection (lowest row) for any of the Glazed openings and indicate the weakest form of protection (lowest row) for Non-Glazed openings. | | Glazed Openings | | | | Non-Glazed Openings | |
|---|---|---|---|---|---|---|---|
| X | No Windborne Debris Protection | X | X | | | X | X |

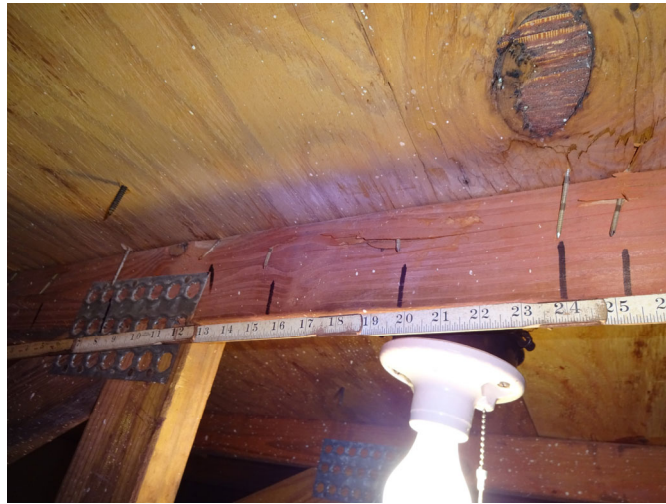
**Figure 5 – Deck to Truss Attachment**

- ☒ C. Plywood/OSB roof sheathing with a minimum thickness of 7/16" inch attached to the roof truss/rafter (spaced a maximum of 24" inches o.c.) by 8d common nails spaced a maximum of 6" inches in the field. -OR- Dimensional lumber/Tongue & Groove decking with a minimum of 2 nails per board (or 1 nail per board if each board is equal to or less than 6 inches in width). -OR- Any system of screws, nails, adhesives, other deck fastening system or truss/rafter spacing that is shown to have an equivalent

or greater resistance than 8d common nails spaced a maximum of 6 inches in the field or has a mean uplift resistance of at least 182 psf.
