# Uniform Mitigation Verification Inspection Form

| Address: 801-804 Mindy Court | | Home Phone: |

**Subject: Uniform Mitigation Verification Inspection Form  
Rothmoor Estates Condominium  
Building 8  
801-804 Mindy Court  
Largo, Florida**

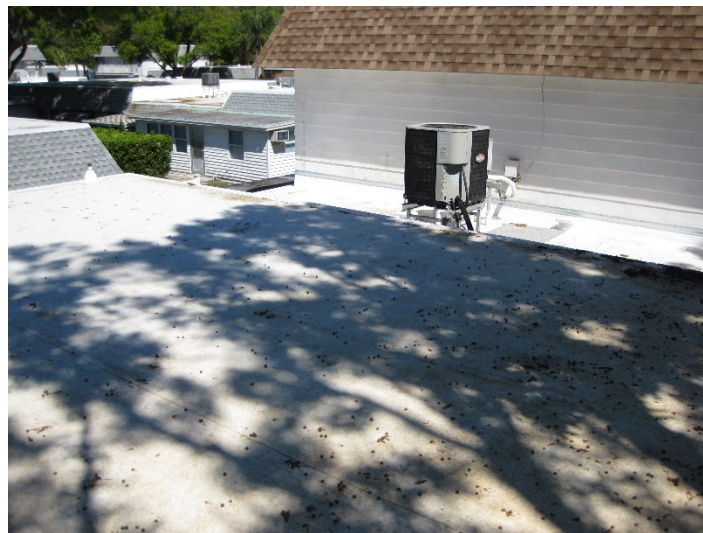
**Figure 1 – Roof Layout**

- ☐ A. Hip Roof      Hip roof with no other roof shapes greater than 10% of the total roof system perimeter.  
Total length of non-hip features: \_\_\_\_\_ feet; Total roof system perimeter: \_\_\_\_\_ feet
- ☐ B. Flat Roof      Roof on a building with 5 or more units where at least 90% of the main roof area has a roof slope of less than 2:12. Roof area with slope less than 2:12 \_\_\_\_\_ sq ft; Total roof area \_\_\_\_\_ sq ft
- ☒ C. Other Roof      Any roof that does not qualify as either (A) or (B) above. 5,200 sq ft flat; 1,900 sq ft mansard

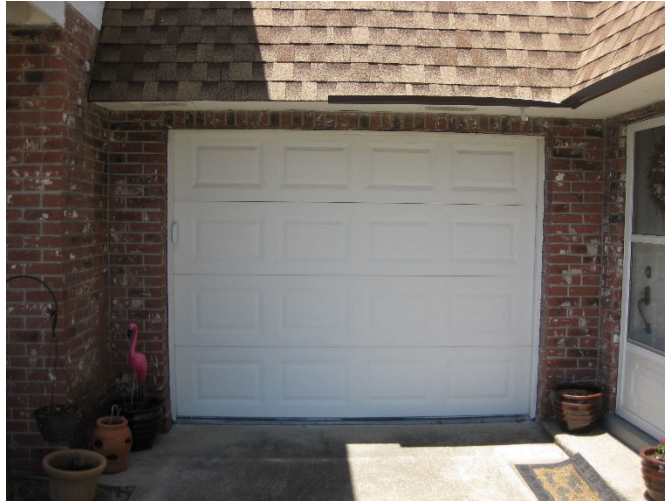
**Figure 2 – Typical Garage Door**

| Opening Protection Level Chart<br>Place an "X" in each row to identify all forms of protection in use for each opening type. Check only one answer below (A thru X), based on the weakest form of protection (lowest row) for any of the Glazed openings and indicate the weakest form of protection (lowest row) for Non-Glazed openings. | | Glazed Openings | | | | Non-Glazed Openings | |
|---|---|---|---|---|---|---|---|
| X | No Windborne Debris Protection | X | X | | | X | X |

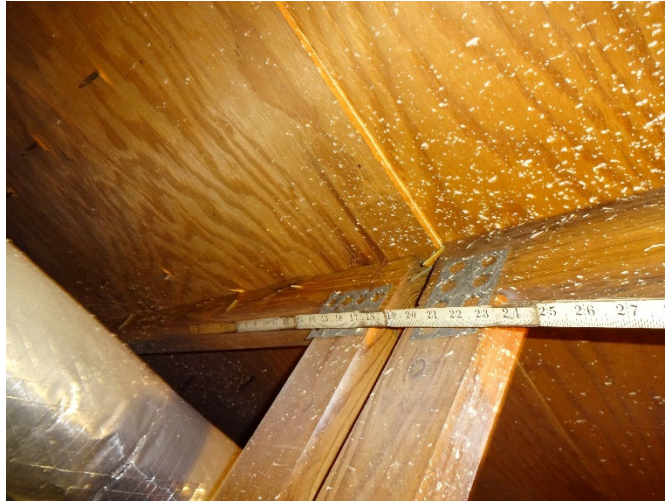
**Figure 5 – Deck to Truss Attachment**

- ☒ C. Plywood/OSB roof sheathing with a minimum thickness of 7/16" inch attached to the roof truss/rafter (spaced a maximum of 24" inches o.c.) by 8d common nails spaced a maximum of 6" inches in the field. -OR- Dimensional lumber/Tongue & Groove decking with a minimum of 2 nails per board (or 1 nail per board if each board is equal to or less than 6 inches in width). -OR- Any system of screws, nails, adhesives, other deck fastening system or truss/rafter spacing that is shown to have an equivalent

or greater resistance than 8d common nails spaced a maximum of 6 inches in the field or has a mean uplift resistance of at least 182 psf.
