# Uniform Mitigation Verification Inspection Form

| Address: 901-908 Cara Drive | | Home Phone: |

**Subject: Uniform Mitigation Verification Inspection Form  
Rothmoor Estates Condominium  
Building 9  
901-908 Cara Drive  
Largo, Florida**

Prescott Engineering, LLC (PE) was requested to provide complete a wind mitigation report for the above listed report. The inspection was completed on May 21, 2019. Below is photographic documentation for the Uniform Mitigation Verification Inspection Form.

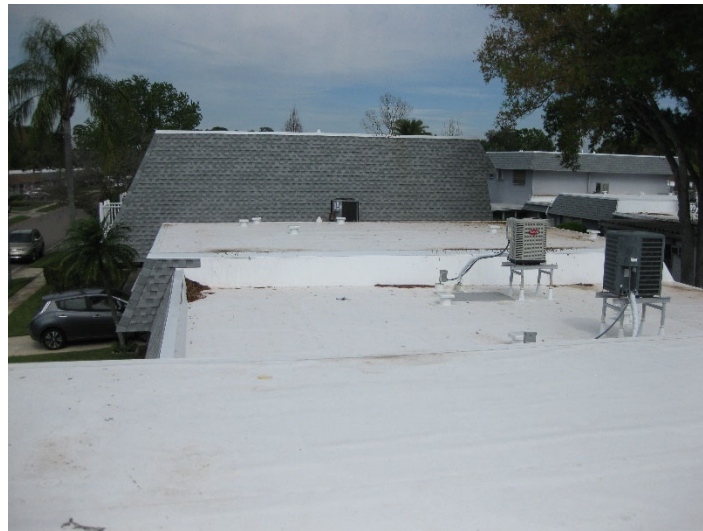
**Figure 1 – Roof Layout**

- ☐ A. Hip Roof      Hip roof with no other roof shapes greater than 10% of the total roof system perimeter.  
Total length of non-hip features: \_\_\_\_\_ feet; Total roof system perimeter: \_\_\_\_\_ feet
- ☐ B. Flat Roof      Roof on a building with 5 or more units where at least 90% of the main roof area has a roof slope of less than 2:12. Roof area with slope less than 2:12 \_\_\_\_\_ sq ft; Total roof area \_\_\_\_\_ sq ft
- ☒ C. Other Roof      Any roof that does not qualify as either (A) or (B) above. 12,000 sq ft flat; 4,200 mansard

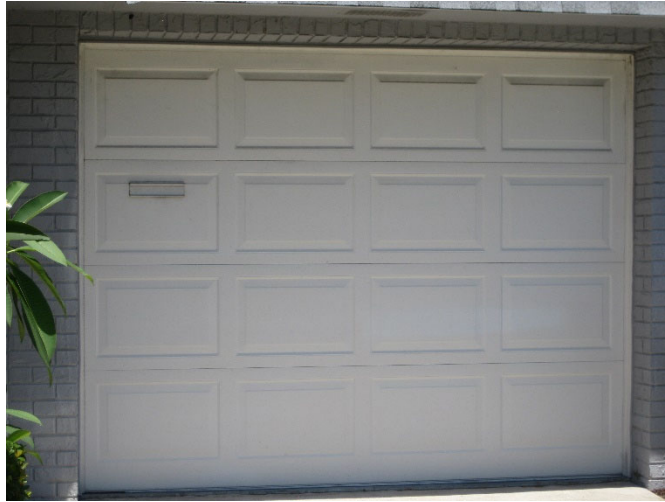
**Figure 2 – Typical Garage Door**

| Opening Protection Level Chart<br>Place an "X" in each row to identify all forms of protection in use for each opening type. Check only one answer below (A thru X), based on the weakest form of protection (lowest row) for any of the Glazed openings and indicate the weakest form of protection (lowest row) for Non-Glazed openings. | | Glazed Openings | | | | Non-Glazed Openings | |
|---|---|---|---|---|---|---|---|
| X | No Windborne Debris Protection | X | X | | | X | X |

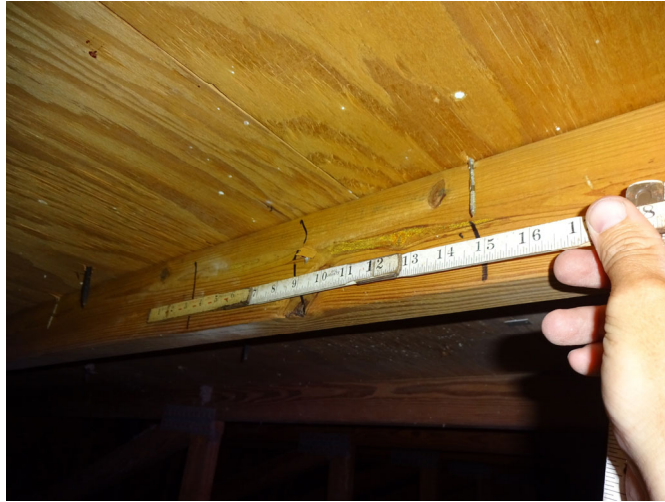
**Figure 5 – Deck to Truss Attachment**

- ☒ C. Plywood/OSB roof sheathing with a minimum thickness of 7/16" inch attached to the roof truss/rafter (spaced a maximum of 24" inches o.c.) by 8d common nails spaced a maximum of 6" inches in the field. -OR- Dimensional lumber/Tongue & Groove decking with a minimum of 2 nails per board (or 1 nail per board if each board is equal to or less than 6 inches in width). -OR- Any system of screws, nails, adhesives, other deck fastening system or truss/rafter spacing that is shown to have an equivalent

or greater resistance than 8d common nails spaced a maximum of 6 inches in the field or has a mean uplift resistance of at least 182 psf.
